# ROBOTIC PIPE SCANNING: INTELLIGENT INTERNAL TOOLKIT FOR CRITICAL WATER MAINS

Elia Hauge<sup>1</sup>, Andrew Bui<sup>1</sup>, Jeya Rajalingam<sup>1</sup>, Nalin Karunatilake<sup>1</sup>, David Hunt<sup>2</sup>, Dammika Vitanage<sup>1</sup>,  
Gamini Dissanayake<sup>2</sup> and Jaime Valls Miro<sup>2</sup>,

## ABSTRACT

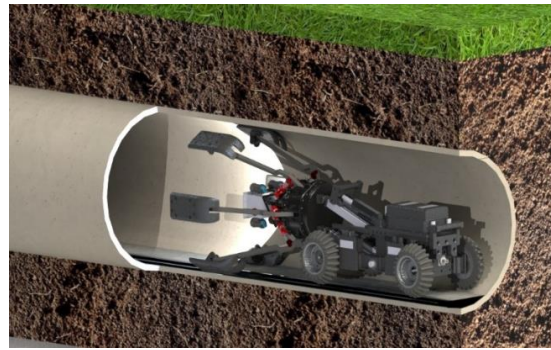
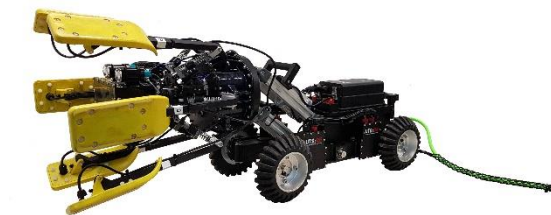
The Mains Break Pipe Wall Inspection Tool (PWIT) shown in Figure 1, is designed to assess a water main either side of a break during the brief window between a main break and its repair. It can operate in cast iron pipes between 375 and 750mm diameter, at a speed of 100m per hour<sup>1</sup> and reach 100m from the entry point. Information gathered can help identify vulnerable pipe segments near the break, enabling replacement as an extended and planned part of the break repair to minimising a repeat service impact to the same customers.

*Figure 1: Mains Break PWIT tool and a pictorial view of it being deployed in a pipe.*

Tool	Mains Break	Planned Operations
Diameter Range (mm)	375-750	400-850
Scan Range (m)	100	500
Scanning Speed (m/h)	100	200
PEC Sensors	6	12
CCTV	Yes	Yes
3D Data	Yes	Yes

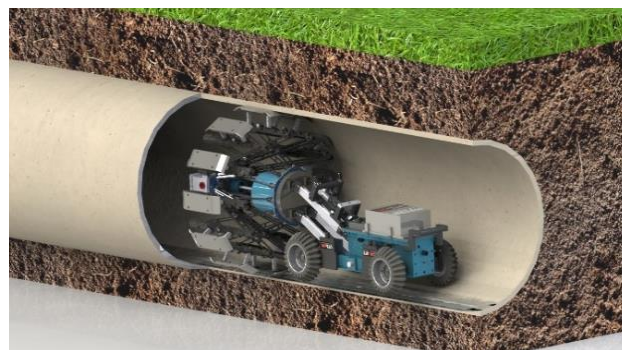
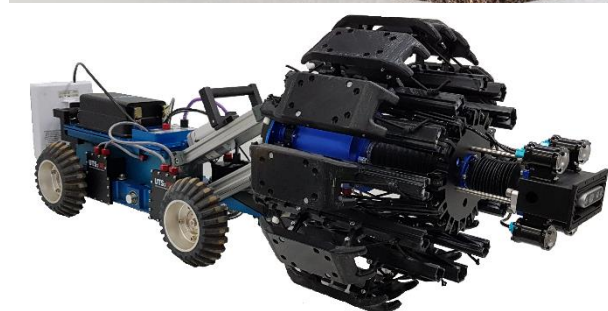
The Planned Operations PWIT (Figure 2) is designed to be used in a water main during a planned shutdown. It can operate in cast iron pipes between 400mm and 850mm diameter, at a speed of 200m per hour and reach 500m from the entry point. Information gathered can be used to identify vulnerable sections and plan an appropriate replacement or relining action. This optimises the lengths of main renewed, saving significantly on renewal costs.

*Figure 2: Planned Operation PWIT tool and a pictorial view of it being deployed in a pipe.*

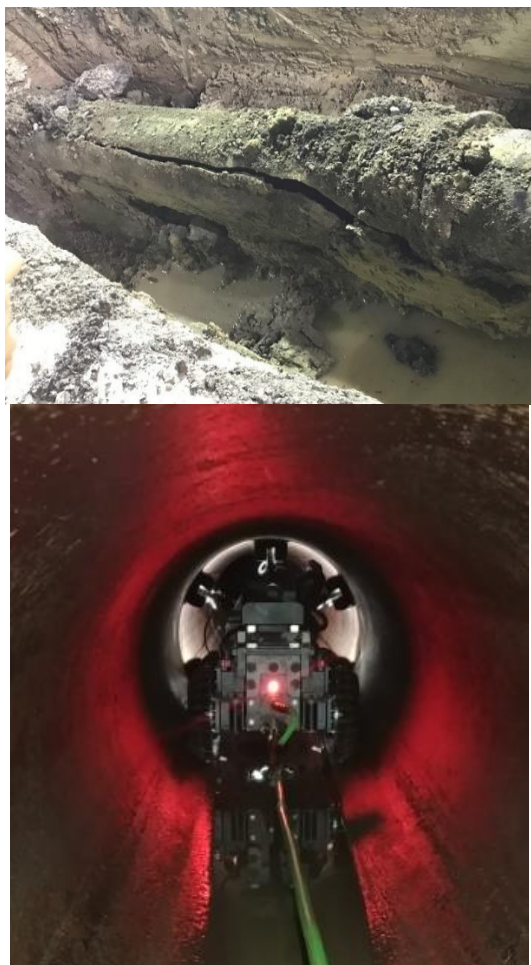
Figure 3: Typical entry pit before the broken pipe is removed and the image of the reactive robot deployed inside the pipe once the broken segment is cut out
